TEMORA SHIRE COUNCIL

**PEDESTRIAN ACCESS and MOBILITY PLAN  
(PAMP)**

February 2019

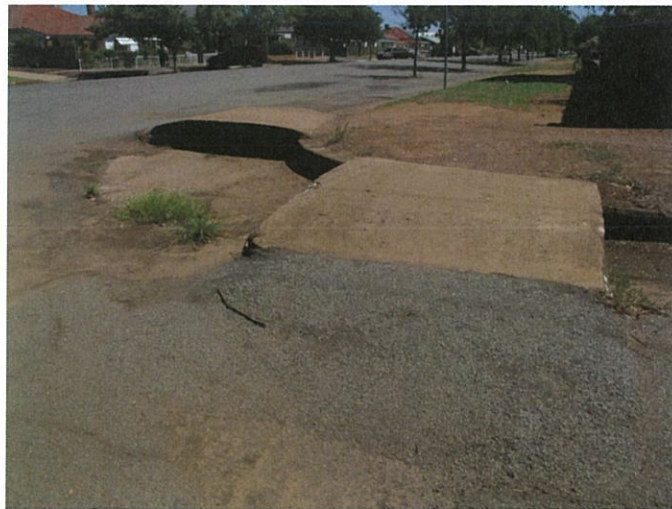
During studies it was found that at six spate intersections locations that there is a total of 17 substandard gutter crossing structures (*Listed on Page A7, Appendix A*), being necessary for future replacement to standard kerb ramps for the following reasons;

1. Inadequate width as an inclusive pedestrian access ramp, not meeting the standard requirements for wheelchair or mobility scooter access
2. No safety railings on the structures preventing persons, wheelchairs or mobility scooters accidentally going off the edge of a structure.
3. Slope grades don't meet Australian Standard and specification requirements, with some structures having a very convex shape

**Photo 1; Example of substandard pedestrian gutter crossing bridges**

Due to these structures being installed many years previous they should be considered for future replacement however aren't scheduled in any short term plans.

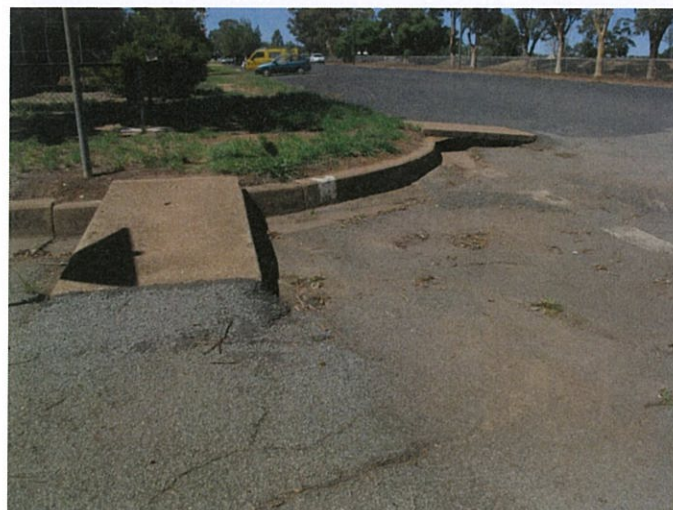
**Photo 2; Example of substandard pedestrian gutter crossing bridges**

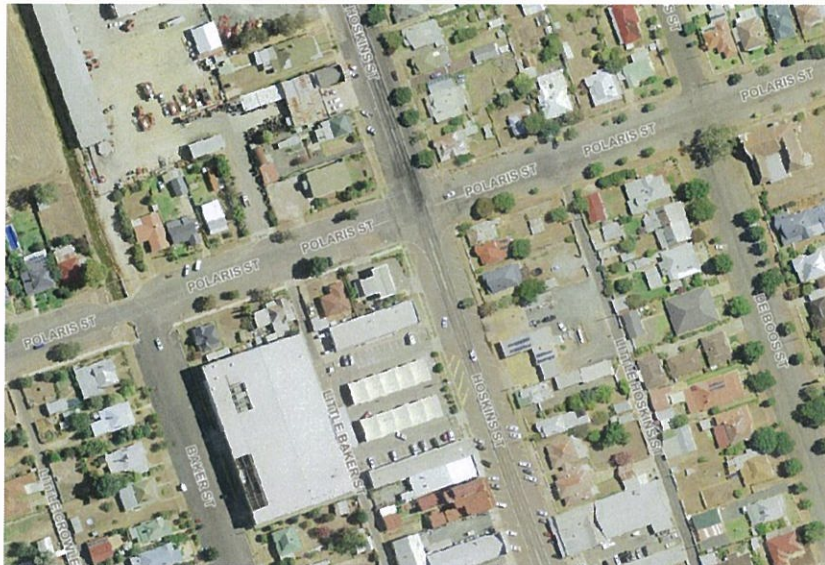
A roundabout is a high priority within the plan at the intersection of Hoskins Street and Polaris Street as a formal and safe way to have pedestrians cross the road at this high risk location. The roundabout is crucial in the aid of installing pedestrian refugees at this intersection due to the wide nature of the sealed pavement and other risk factors including traffic volumes at the intersection due to the entry into Woolworths fuel outlet, an exit from Woolworths carpark, turning traffic from either side of Polaris Street and through traffic on Hoskins Street. (see Photo 3 below).

**Photo 3; Hoskins and Polaris Street Intersection**

A roundabout will improve the flow of traffic and also allow provisions for pedestrian refugees to be installed for pedestrians to use a two-step approach in crossing the road. Drivers will also then only need to concentrate on vehicles to their right within the roundabout and whether a pedestrian has started to cross the road at a refugee location.

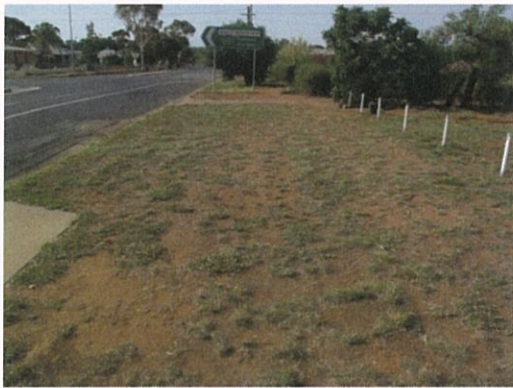
**Photo 44**

38	Parkes St	S	Deboos St W	Existing footpath between Deboos St and Recreation Centre needs replacing due to poor condition	Replace Footpath (3.5m)	120	m	L	\$55,200	38	> 10 years	
39	Baker St	E	Polaris St N	No Footpath (Section already existing at rear of Woolworths building)	Construct New Footpath (1.5m)	130	m	L	\$19,500	39	> 10 years	
40	Gallipoli St	W	Loftus St N	No Kerb Ramp	Install Kerb Ramp	1	item	L	\$2,500	40	> 10 years	
41	Gallipoli St	W	Loftus St N	No Footpath	Construct New Foot path (1.5m)	436	m	L	\$65,400	41	> 10 years	
42	Victoria St	N	Gallipoli St E	No Footpath	Construct New Foot path (1.5m) Install Access Ramp	45 2	m item	L	\$11,750	42	> 10 years	
43	Britannia St	N	Deboos St W	No Footpath	Construct new Foot path (1.5m)	110	m	L	\$16,500	43	> 10 years	
44	Britannia St	S	Baker St E	No Footpath between Hoskins Street and Railway Access to Temora West Southern End	Construct new Foot path (1.5m)	240	m	L	\$36,000	44	> 10 years
