**47-63 GALLIPOLI STREET  
TEMORA NSW 2666**

**PRELIMINARY  
SITE INVESTIGATION**

**FOR THE PROPOSED  
REZONING OF LAND**

**REPORT NO: 9668**

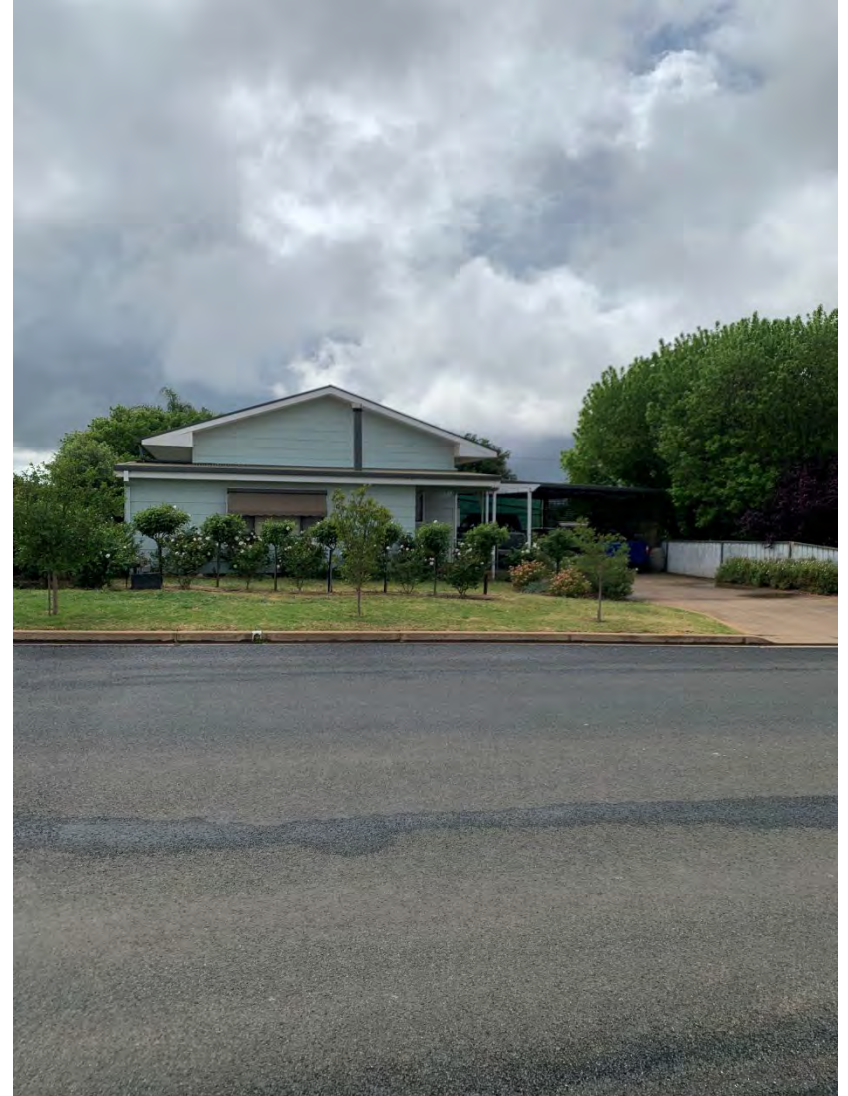
- A single storey weatherboard house with tin roof and attached carport built prior to 1961 exists in the north west corner of the lot. The house likely contains asbestos in the cladding and in the meter box although a thorough inspection for hazardous materials was outside the scope of work.

Photograph 6: Single storey weatherboard house at 47-53 Gallipoli Street, facing east.

- If the houses at 57 Gallipoli Street and 47-53 Gallipoli Street are proposed to be demolished or renovated, it is recommended that a licenced professional is engaged to undertake a hazardous building materials assessment and removal as necessary. This is normally a standard development consent condition.
- The septic system at 57 Gallipoli Street if present, will require decommissioning during development which is normally a standard development consent condition. Septic systems that are regulated by Council present low health and environmental risk when regularly inspected and serviced.

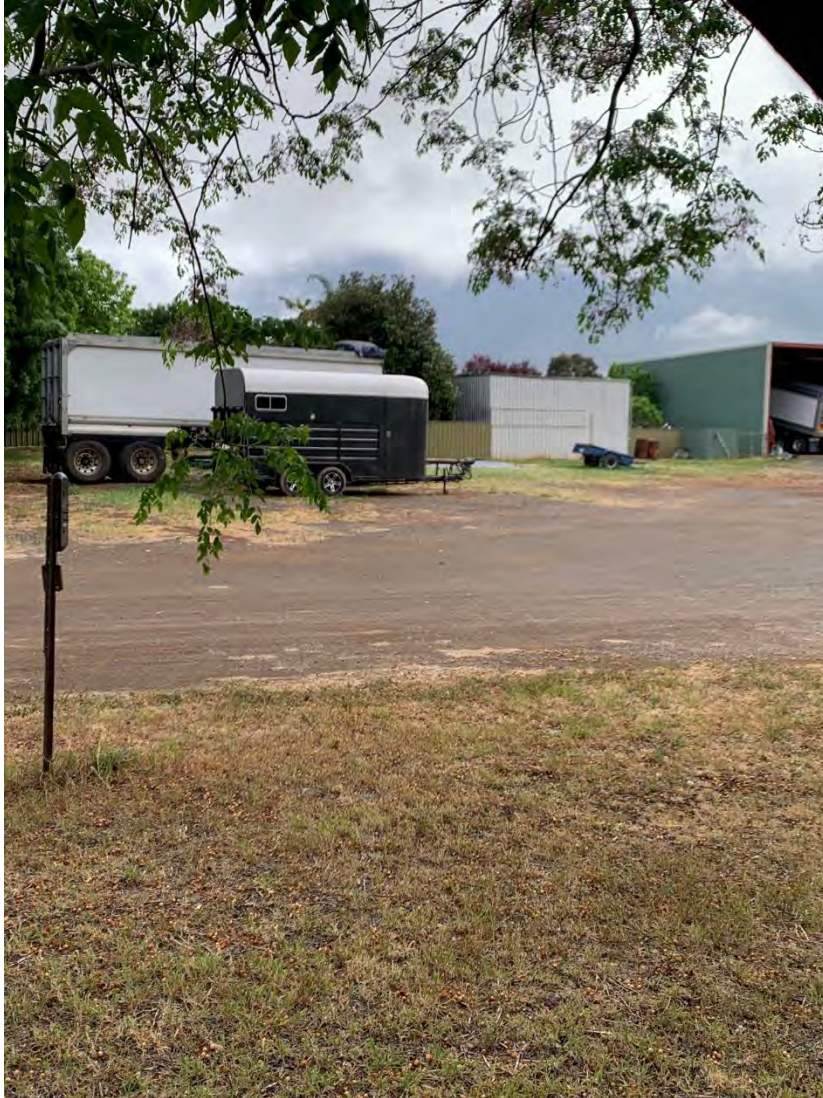
- A truck trailer, horse float and box trailer were parked to the south of the house.
- A large slab on grade steel shed to the east of the house contains another truck trailer, hay bales, steel drums, stacked tyres, pallets, and plastic intermediate bulk containers. Chemical storage is likely to be present. Fuel storage was not observed but access was compromised at the time of investigation.

Photograph 7: Truck trailer, horse float and box trailer parked to the south of the house at 47-53 Gallipoli Street, facing north.

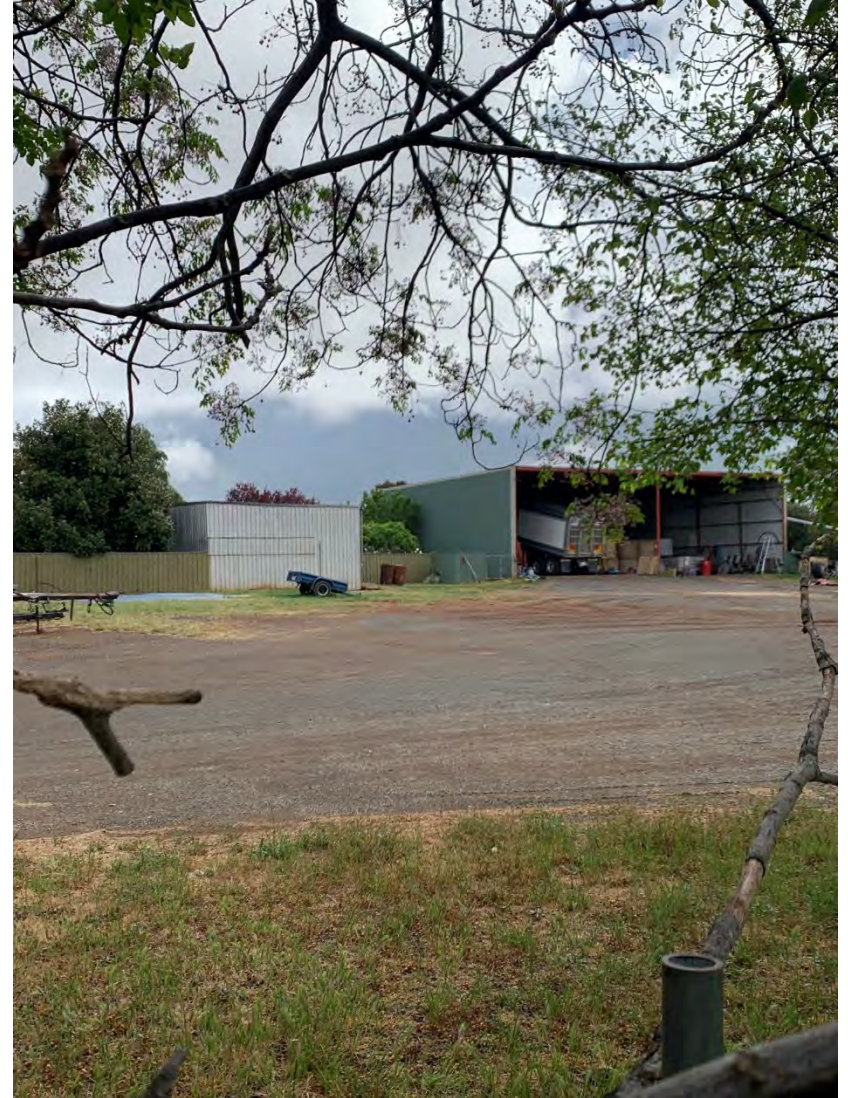
- Chemical storage in the shed is likely and household chemicals, cleaning supplies and weed management supplies were observed in front of the large outbuilding. However, these sources are assessed to be low risk as the chemicals are stored in or near the slab on grade shed and any potential spills or leaks are considered to be localised.

Photograph 8: Large slab on grade shed to the east of the house at 47-53 Gallipoli Street, facing north.

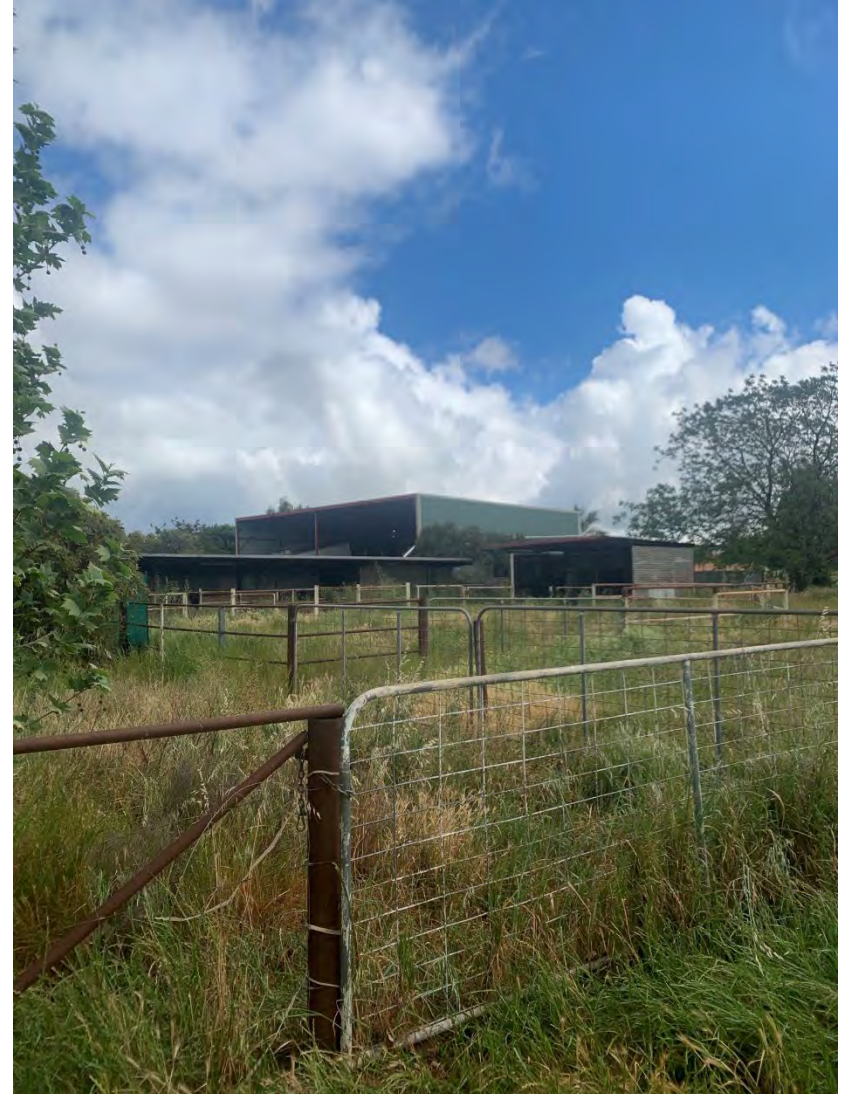
- The site inspection found the former home nursery was a small-scale business and gross contamination from agricultural chemicals is unlikely. The size and nature of the business (selling plants and ceramic pots) suggests that widespread agricultural chemical use was limited. Contamination from agricultural chemicals in the animal yards is also unlikely as no livestock were observed in the yards at the time of investigation or in the available aerial photographs.

Photograph 10: Animal shelter and attached yard at 47-53 Gallipoli Street, facing north west.

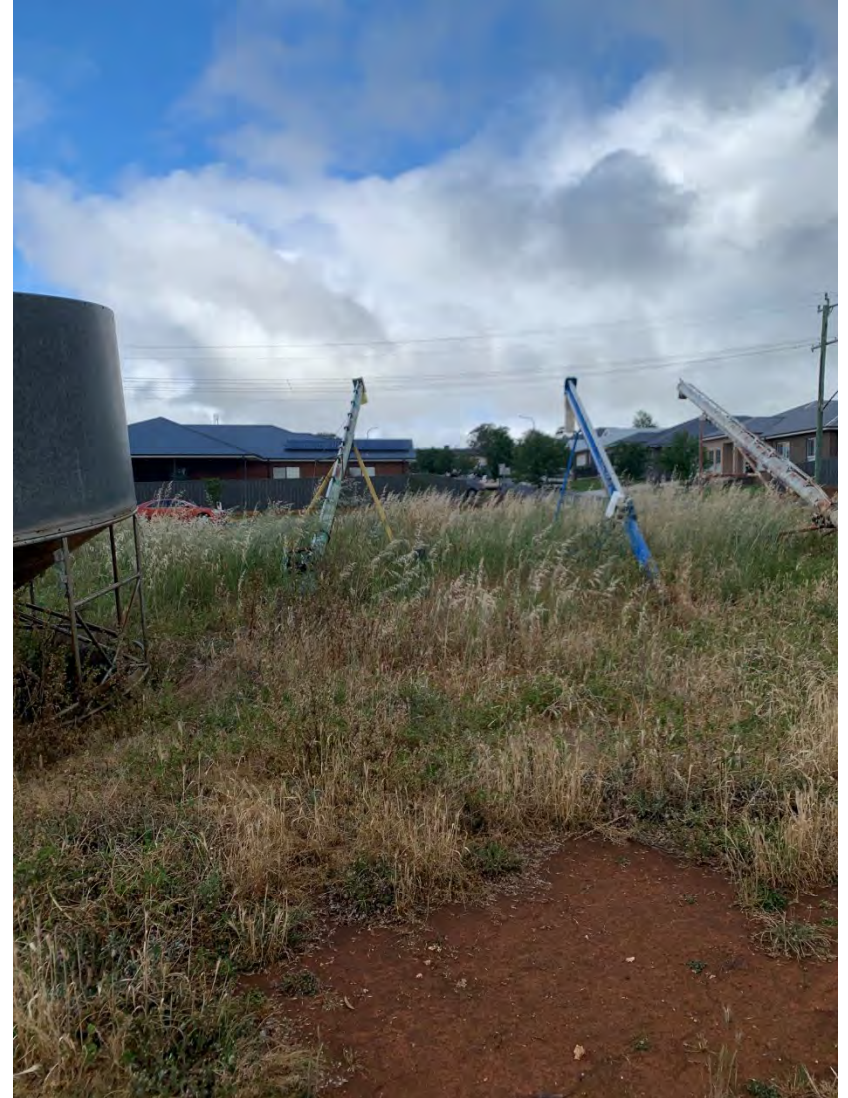
- Gross contamination from fuel and oil leaks and spills at 59-63 Gallipoli Street is considered to be unlikely as no machinery or vehicles were parked at the time of investigation and no visual or olfactory indicators of contamination were observed. However, a thorough visual inspection was hampered by thick grass.

- Lot 5 is currently being used as a laydown area for grain augers, machinery parts, steel drums, a silo, and a small incinerator. This area is likely used by the adjacent metal fabrication/engineering workshop to the south. No fuel storage was observed. No spills or staining from fuel and oil were observed on the areas of bare ground however, thick grass hampered a thorough inspection of the majority of the site surface.

Photograph 18: Laydown area at Lot 5 59-63 Gallipoli Street,  
facing west.

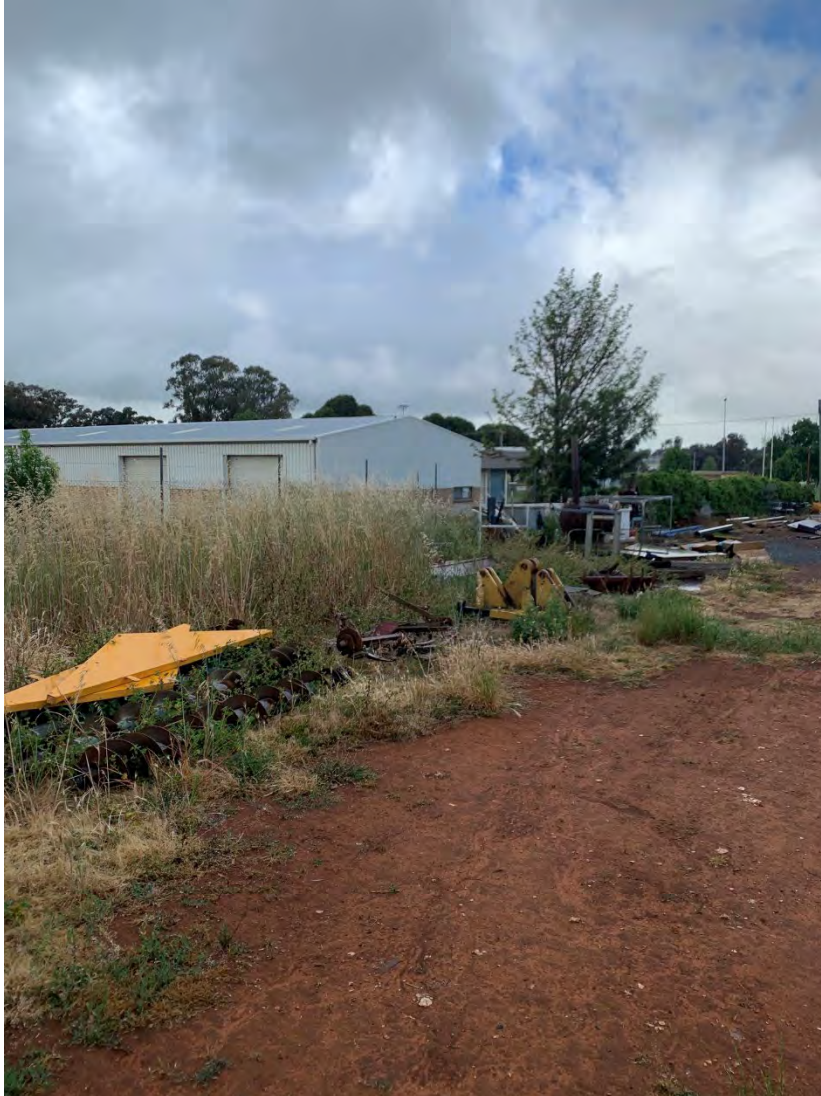
Photograph 19: Laydown area at Lot 5 59-63 Gallipoli Street, facing south east.

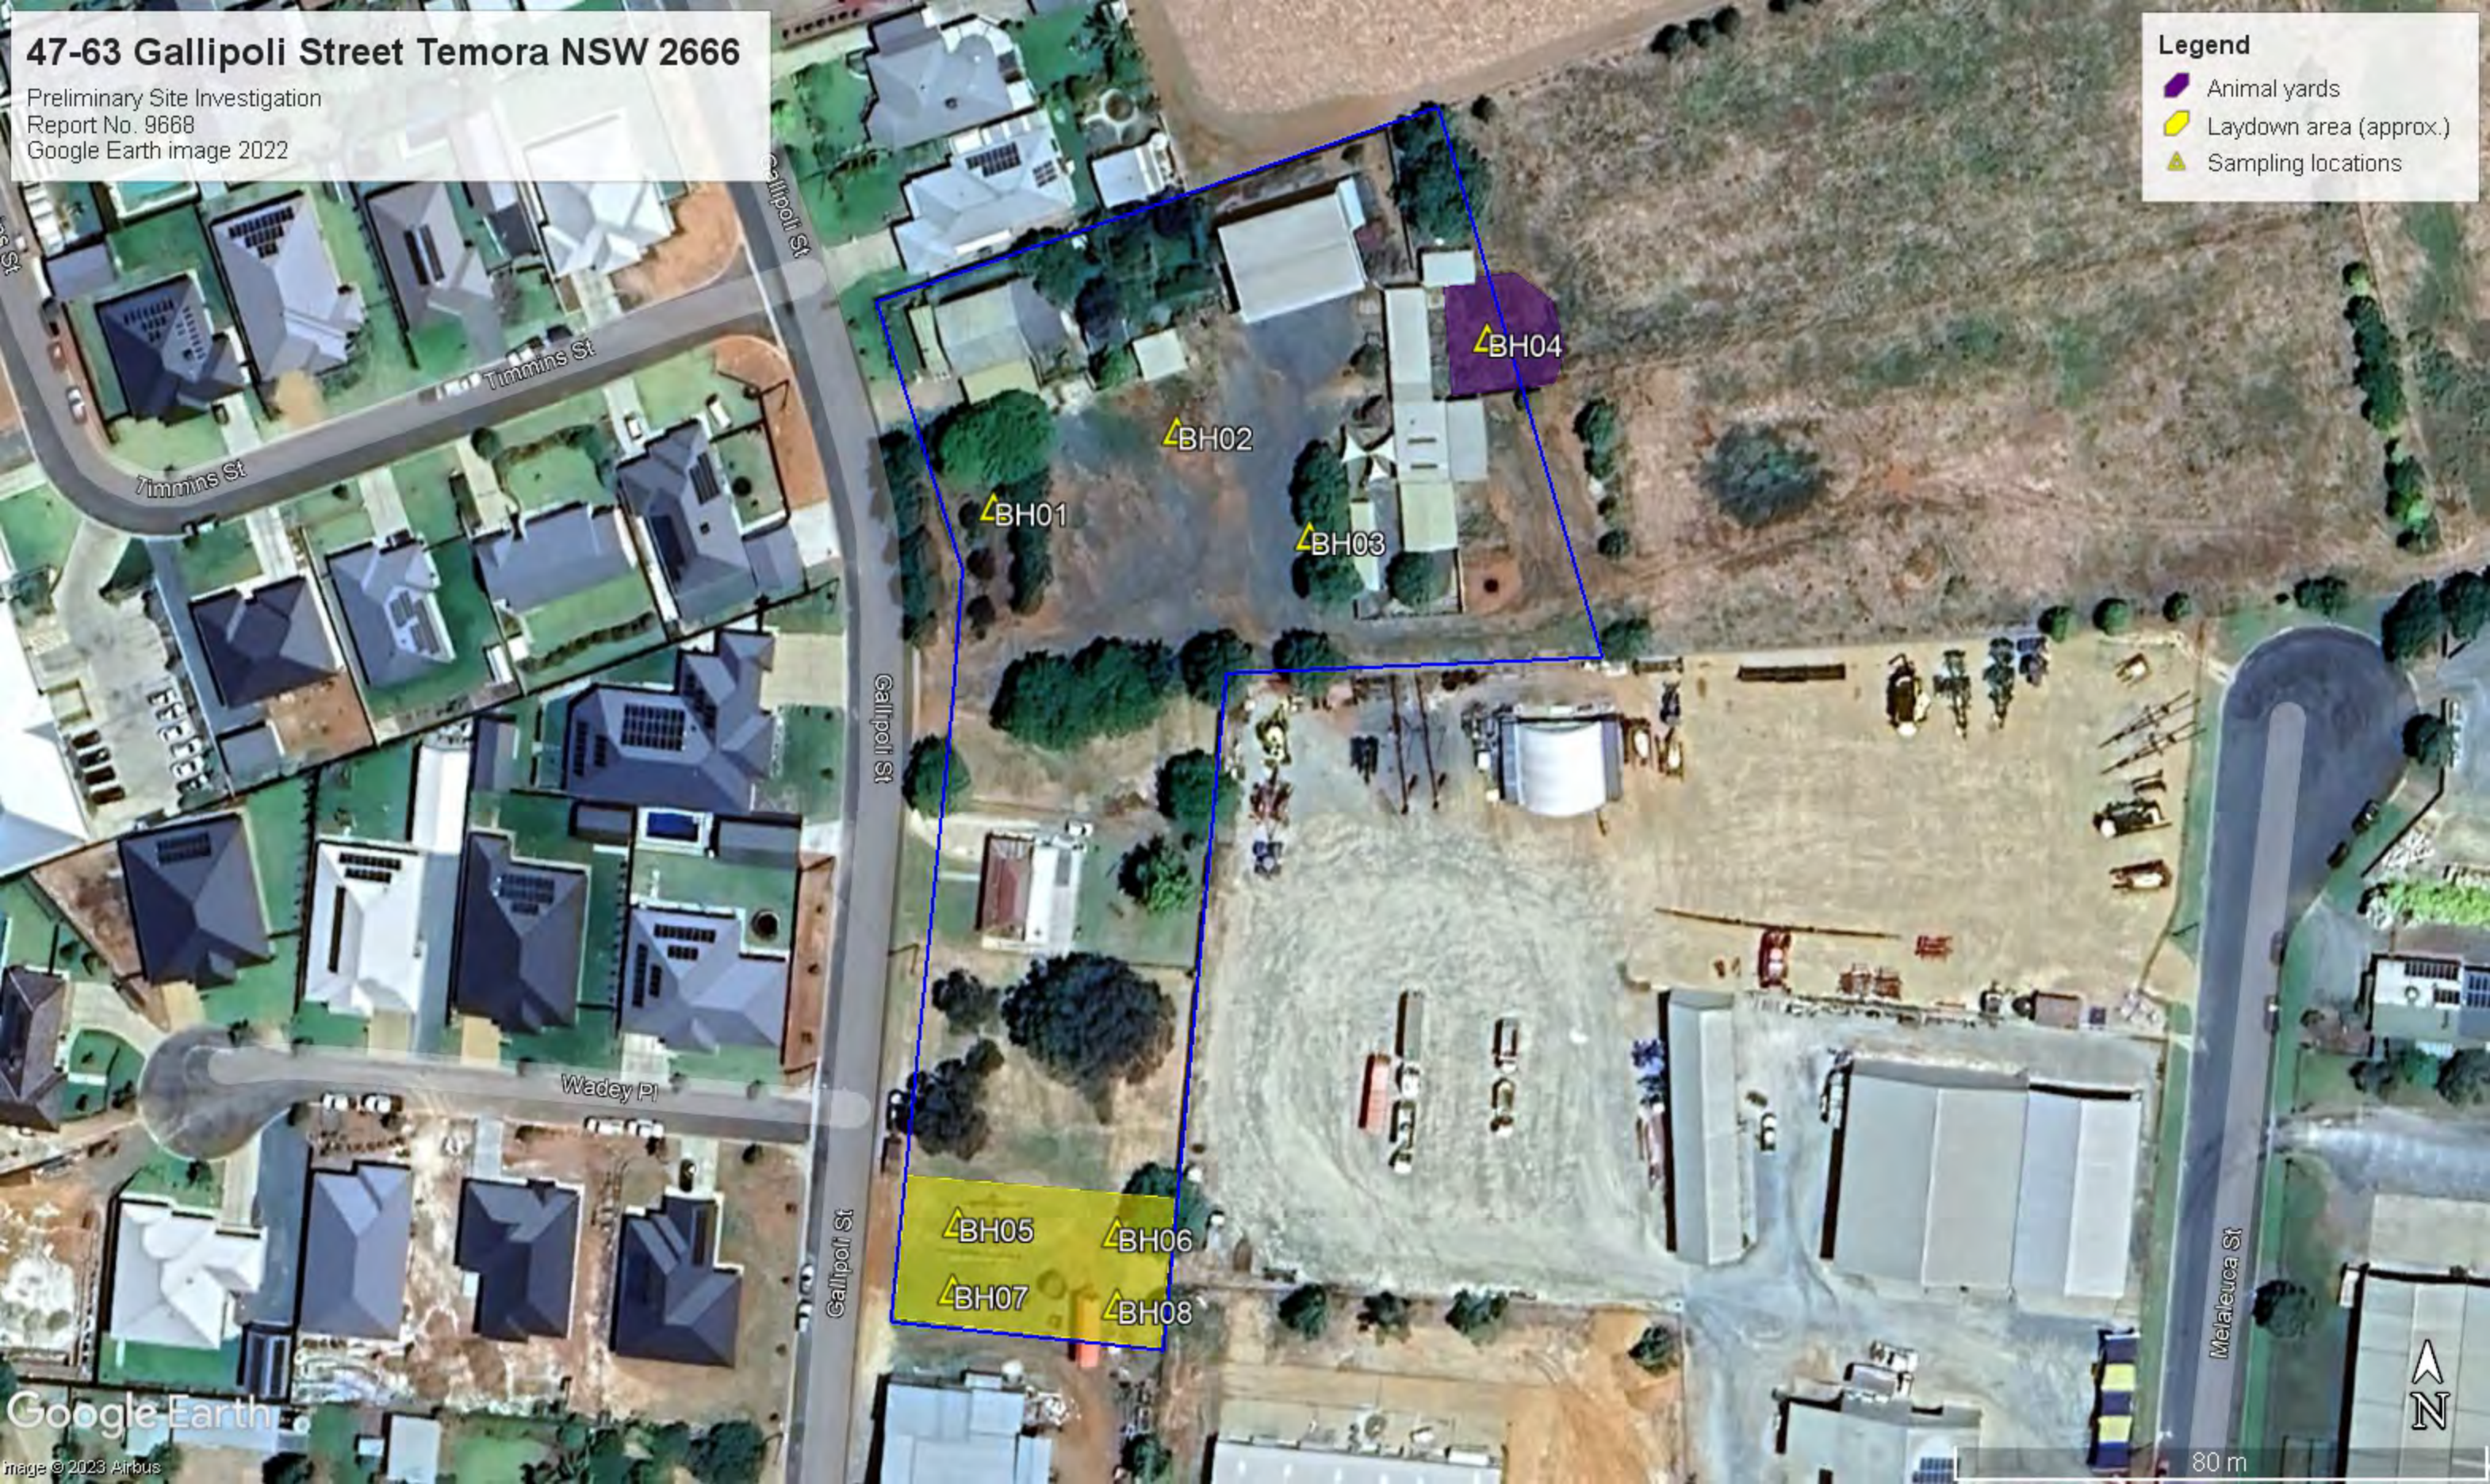
Sampling locations

- Samples 1-3: to assess the near surface soil contamination from potential persistent agricultural chemicals from the former home nursery business.
- Sample 4: to assess the near surface soil contamination from potential persistent agricultural chemicals from application in the animal yards.
- Sample 5-8: to assess the near surface soil contamination from potential fuel and oil leaks and spills in the laydown area.
